**Affected GMB Part Numbers: 115-2260, 115-2270 Electric Water Pumps**  
**Applications: BMW 2006-2013 (E90-93)**  
**Issue: 2E82/2E84/2E85 Engine Codes**

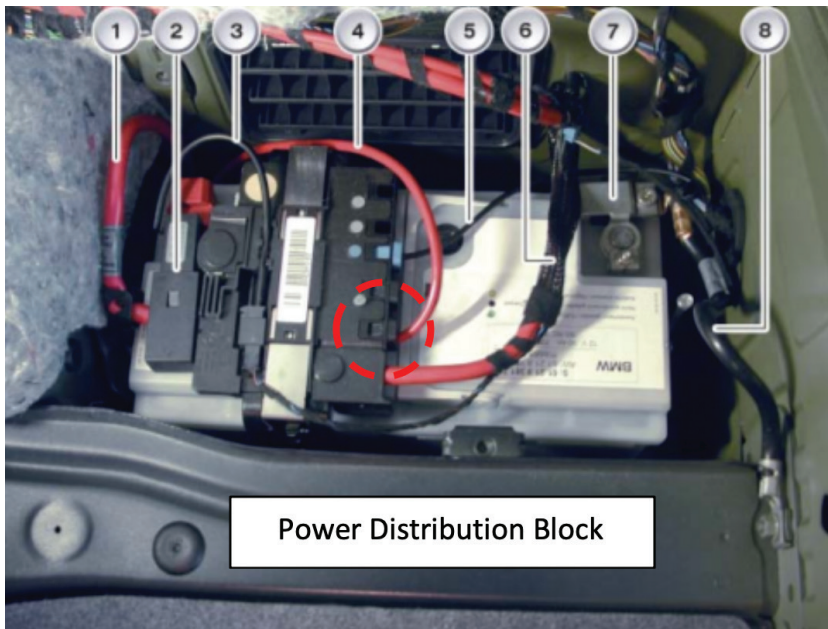
Index	Explanation
1	B+ to Starter & Alternator
2	Battery Safety Terminal (BST)
3	Connection from MRS to BST
4	B+ to Engine Electronics
5	B+ for IBS Electronics
6	B+ to Junction Box
7	Intelligent Battery Sensor (IBS)
8	Battery Ground

2. Once the distribution block cover is removed, first check that the wire harnesses are properly connected with no corrosion present on the terminals.
3. To check for blown fuses in this unit, remove the wire harnesses #4 and #5, referring to the diagram on the next page
4. Referring to the same diagram, using a multimeter check the voltage on the BST, and the leads for #4, #5, and #6. All of them should read around 12V. #4 is the power lead for the electric water pump

5. If the BST is not returning voltage, charge or replace the battery.
6. If the BST is reading 12V but any of the leads are returning no voltage, it means the power distribution block has blow fuses.
7. If blow fuses are found, replace the Power Distribution Block. These fuses are non-serviceable, so full unit replacement is required.
